# LEGIONELLA RISK ASSESSMENT

| <b>Site:</b> | 2185 Wareham ATC |
| <b>Report Ref:</b> | AQST/LRA/403 |
| <b>Survey Date:</b> | 30 <sup>th</sup> January 2024 |

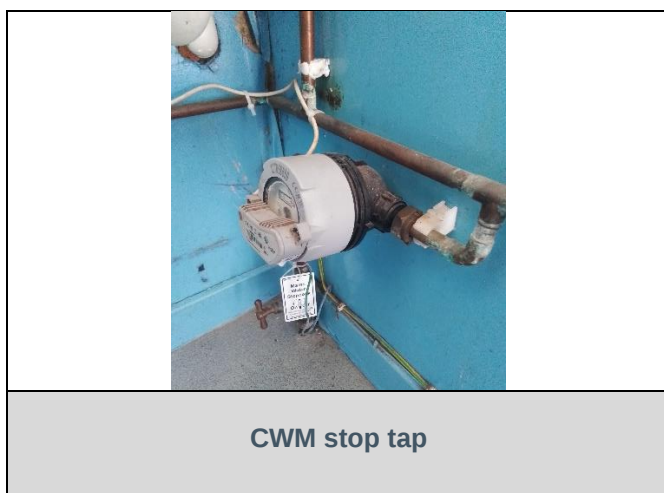
### Photos

| Mains Water Supply Risk Score | Low |

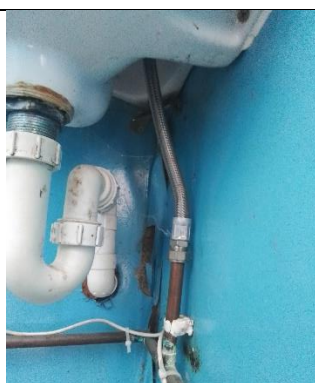
Flexi's

| SYSTEM TYPES | | RISK RATING |
|---|---|---|
| 01 | Flexi's should be WRAS approved or hard piped where possible | Medium |
