LEGIONELLA RISK ASSESSMENT

| Site: | Liskeard ACF |
| Report Ref: | AQST/LRA/166 |
| Survey Date: | 8 th August 2023 |

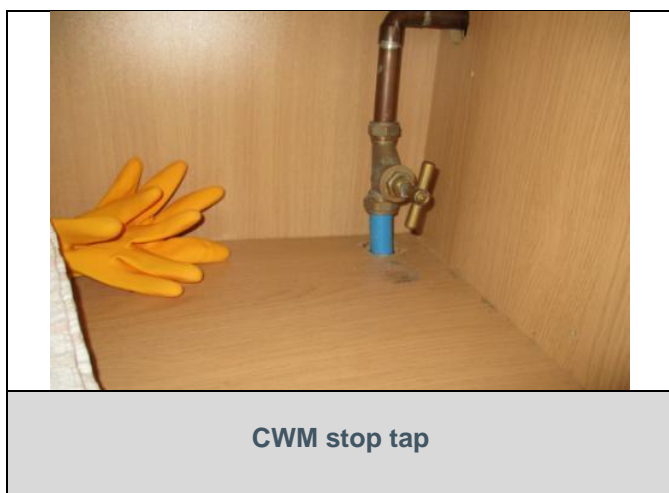
Photos

| Location of main isolation valve? | Kitchen under sink |
| Materials of construction | Copper |
| Mains water temperature °C (sentinel outlets) | Nearest Tap to Incoming Main 17°C Furthest Tap from Incoming Main 17°C |
| Mains Water Supply Risk Score | High |

| SYSTEM TYPES | | RISK RATING |
|---|---|---|
| 01 | CWM stop tap should be clearly labelled | |

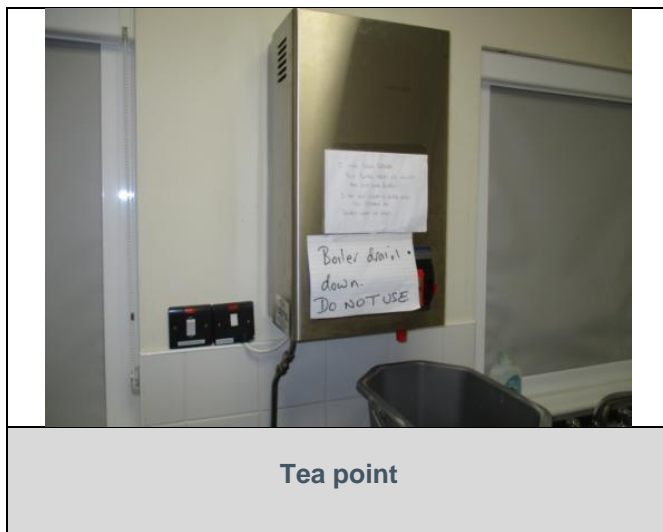
| LOCATIONS | SYSTEM | ACTION |
| Kitchen tea point | Mains water | Repair, replace or remove |

| SYSTEM TYPES | | RISK RATING |
|---|---|---|
| 01 | Tea point is isolated thus connecting pipework cannot be purged and forms a dead leg, repair, replace or remove at source | High |

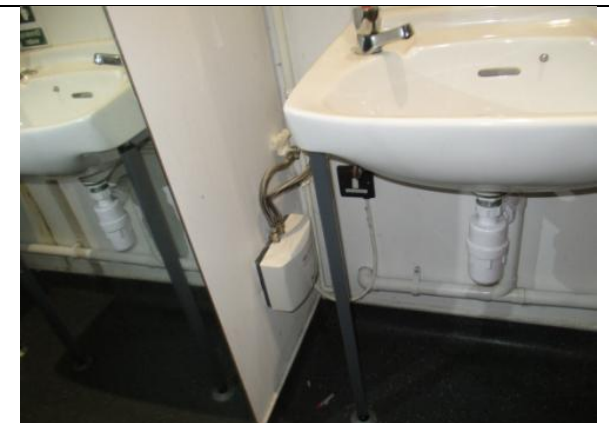
| Water Heater ID Number | Location | Make/model and capacity of each heater | Mains or tank fed | Full clean possible | EXPANSION VESSEL INFO | |
|---|---|--|---|---|---|--|
| WH 04 | Male wc | Zip inline | Mains | No | No | |

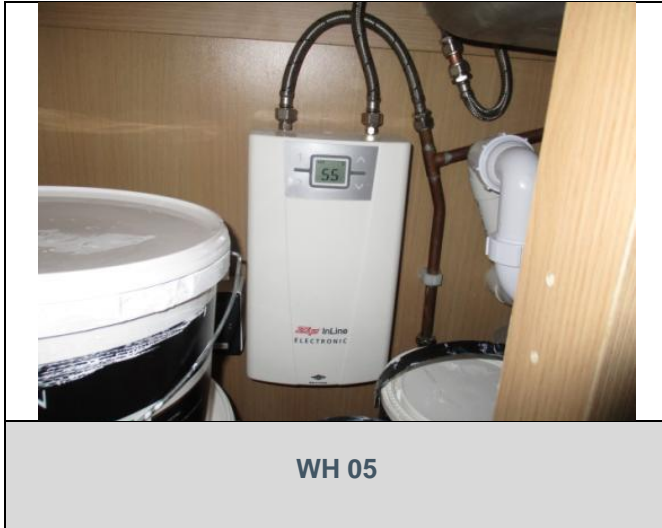
| Water Heater ID Number | Location | Make/model and capacity of each heater | Mains or tank fed | Full clean possible | EXPANSION VESSEL INFO | |
|---|---|--|---|---|---|--|
| WH 05 | CAA store | Zip inline | Mains | No | No | |
