LEGIONELLA RISK ASSESSMENT

THE PREVENTION AND CONTROL OF LEGIONNAIRES' DISEASE

Client:	Wessex RF & CA
Site:	Royal Wessex Yeomanry C (RGH) Squadron (Cirencester)
Address:	Royal Wessex Yeomanry C (RGH) Squadron (Cirencester) Gloucestershire, GL7 TT
Risk Rating:	Medium
Report Ref:	AQST/LRA/313
Surveyed By:	Alan Rodgerson
Survey Date:	06/03/2024
Report Date:	01/05/2024
Written By:	Alan Rodgerson
Checked By:	J. Rooney
Recommended Review Date:	06/03/2026

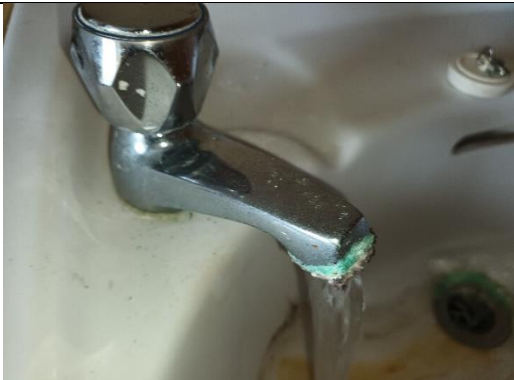
Scale on outlets	Flexible hoses

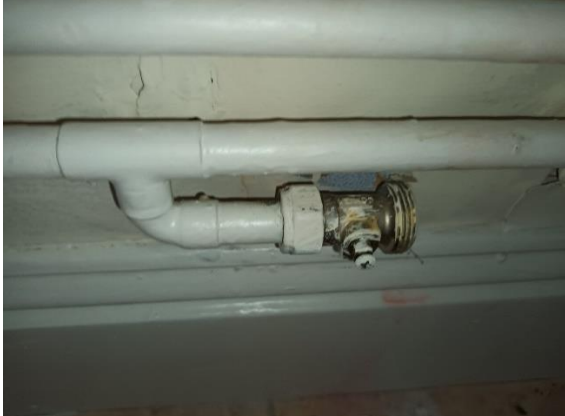
Dead leg in the Caretaker's kitchen	Bib tap in hangar

LOCATIONS	SYSTEM	ACTION
Caretakers' kitchen	MCWS	Remove completely
Hangar	MCWS	Add the bib taps to the flushing list.

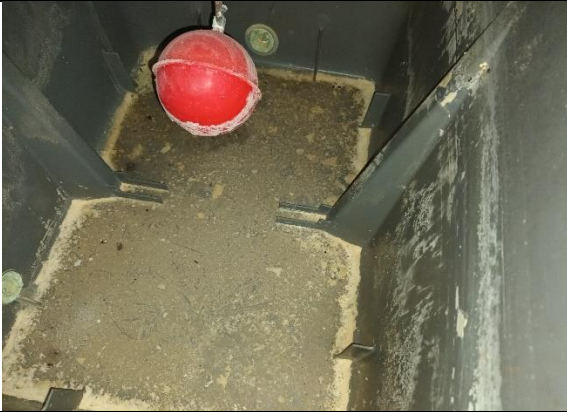
No functioning cold water storage tanks on site. The CWST in the roof space above the caretaker's flat is still in situ but drained down and isolated. It used to serve the defunct calorifier in the caretakers flat.

Redundant CWST

SYSTEM TYPES		RISK RATING
COLD WATER MAINS:		
No action required		Low
Actioned date:	Company/initials:	
COLD WATER STORAGE TANKS:		
Remove the redundant CWST and all associated pipe work.		Medium
Actioned date:	Company/initials:	
HOT WATER CALORIFIERS:		
None on site		Low
Actioned date:	Company/initials:	
HOT AND COLD WATER SYSTEMS:		
Check all flexible hoses are WRAS approved. Replace those that are not.		Medium
Actioned date:	Company/initials:	
Descale all outlets on a regular basis		Medium
Actioned date:	Company/initials:	
Fit non-return valves to the two bib taps in the Hangar		Medium
Actioned date:	Company/initials:	
DEAD LEGS AND BLIND ENDS:		
See schedule 6.6 for remedial actions.		High
Actioned date:	Company/initials:	
POINT OF USE WATER HEATERS:		
Restore the POUWHs in the ATC and the service bay to full working order ensuring a delivery temperature of 50°C		High
Actioned date:	Company/initials:	
TMVs AND TMTs:

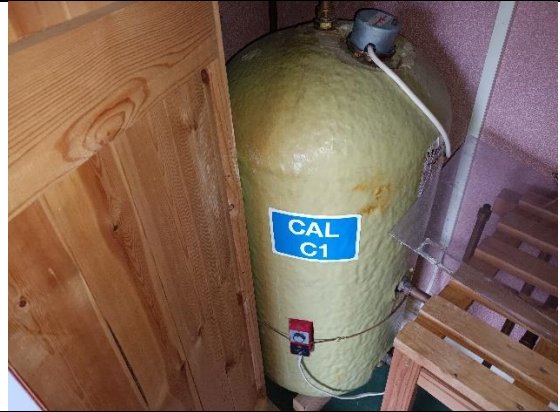
Redundant calorifier
