## LEGIONELLA RISK ASSESSMENT

<b>Client:</b>	Wessex RF & CA
<b>Site:</b>	Bude ACF
<b>Address:</b>	Kings Hill Industrial Estate, Bude, Cornwall EX23 8QN
<b>Risk Rating:</b>	Medium
<b>Report Ref:</b>	AQST/LRA/133
<b>Surveyed By:</b>	Stephen Cross MWMSoc
<b>Survey Date:</b>	8 <sup>th</sup> August 2023
<b>Report Date:</b>	7 <sup>th</sup> September 2023
<b>Recommended Review Date:</b>	August 2025

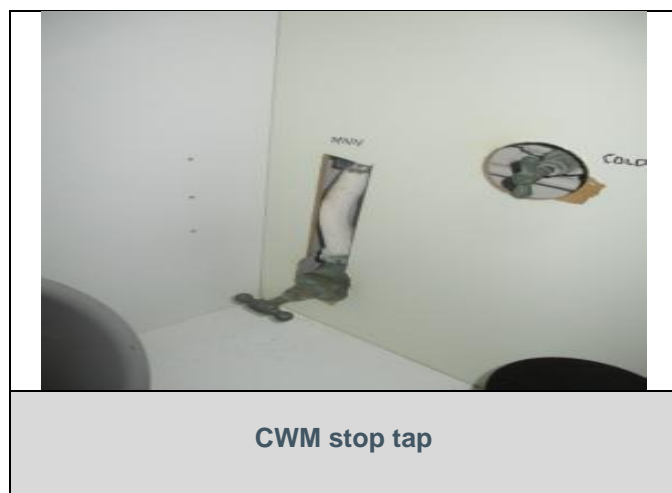
### Photos

Source of supply	Mains
Number of mains cold water supply?	1
Location of main isolation valve?	Under kitchen sink
Is there a water meter installed?	Unknown
Is the pipework labelled?	Yes
Materials of construction	Copper
Are there any materials or fittings visibly present on the mains water system, that do not conform to the Water Regulations Advisory Scheme (WRAS) directory?	None found
Mains water temperature °C (sentinel outlets)	Nearest Tap to Incoming Main 20°C Furthest Tap from Incoming Main 20°C
Are all other distribution temperatures that were tested within the correct temperature range? i.e. Below 20 °C?	No - due to elevated summer temperature
Are there any none flow through expansion vessels to any services on this system?	Yes
Is the pipework suitably insulated?	No
Does the cold-water supply have any inline filters including scale inhibitors/softeners?	None found
<b>COMMENTS</b>	
Mains Water Supply Risk Score	<b>High</b>

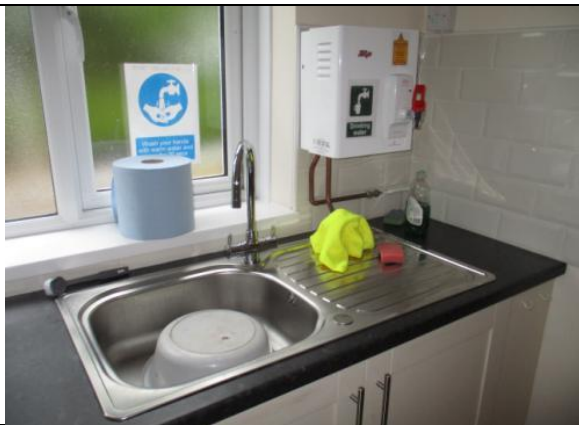
LOCATIONS	SYSTEM	ACTION
Kitchen Tea Point	Mains	Not working – therefore not used for its intended purpose resulting in stagnating water in connecting pipe work. Flush weekly

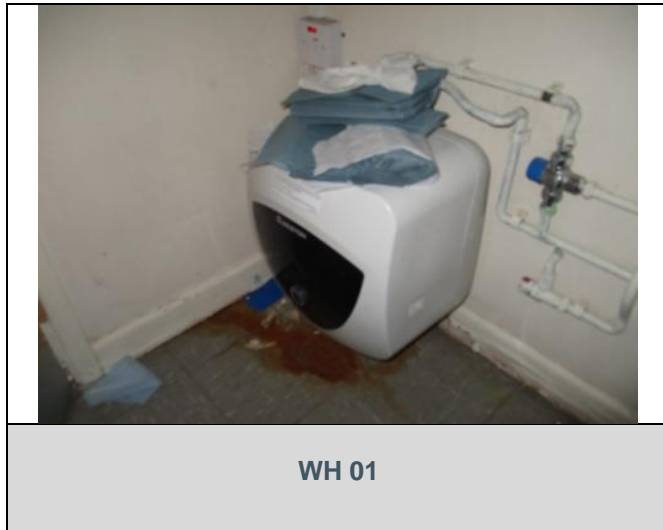
Water Heater ID Number	Location	Make/model and capacity of each heater	Mains or tank fed	Full clean possible	EXPANSION VESSEL INFO	
					Is there a pressure vessel – Yes/No	If yes – make model and size and whether fitted horizontally or vertically
WH 01	Female toilet	Ariston 15ltr	Mains	No	Yes	2ltr vertical
CMB 01	Store	Maxi	Mains	No	No

SYSTEM TYPES		RISK RATING
	<b>POINT OF USE WATER HEATERS:</b>	
01	WH 01 has power but is not heating – requires repairing or replacing	High
	Actioned date:                      Company/initials:	
	<b>GENERAL: Control Schemes</b>	
01	Tea point is not working – requires replacing	High
	Actioned date:                      Company/initials:	
02	Flush outlets weekly to replenish with wholesome water	Low
	Actioned date:                      Company/initials:	
03	Temperature checks should be carried out on a monthly basis and recorded in the log book	High
	Actioned date:                      Company/initials:

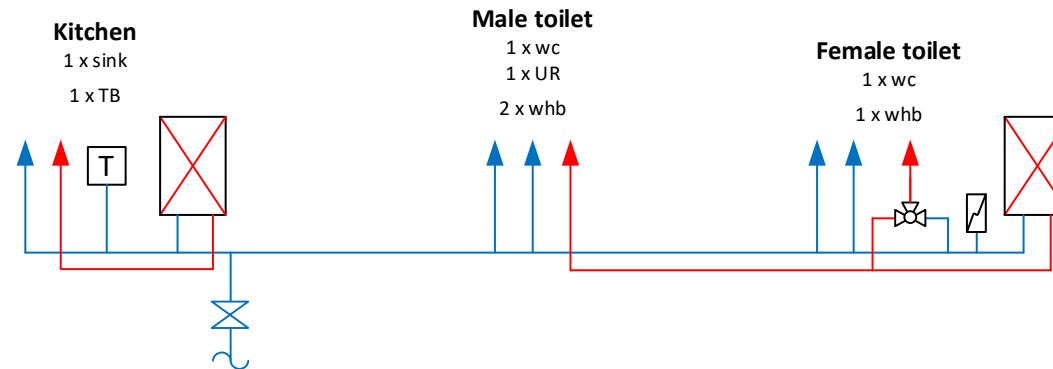
## 8. LINE DRAWINGS OF WATER SYSTEMS

NB: Due to the complexity of the pipe work at this site it is not possible to ensure the total accuracy of these line drawings. They may require revision.
