## LEGIONELLA RISK ASSESSMENT

### THE PREVENTION AND CONTROL OF LEGIONNAIRES' DISEASE

| <b>Site:</b> | Torpoint ACF |
| <b>Report Ref:</b> | AQST/LRA/177 |

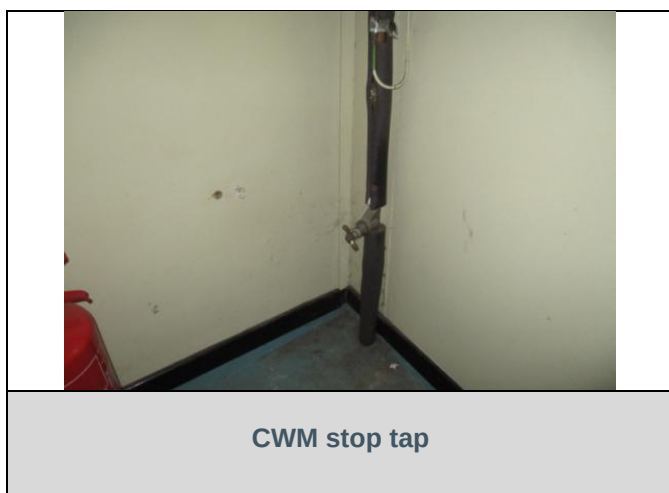
### Photos

| Materials of construction | Copper |
| Mains water temperature °C (sentinel outlets) | Nearest Tap to Incoming Main 18°C<br>Furthest Tap from Incoming Main 19°C |
| Mains Water Supply Risk Score | Low |

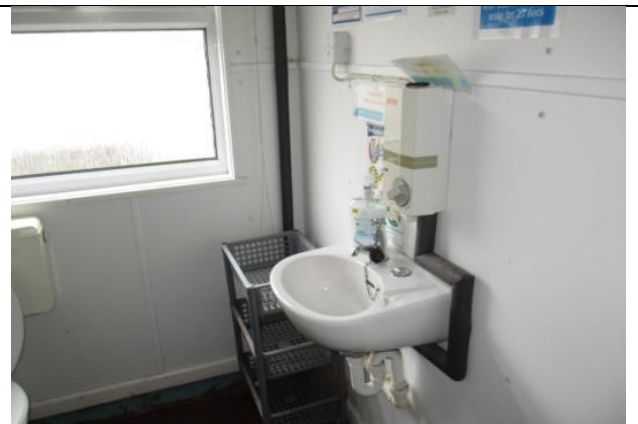
| Water Heater ID Number | Location | Make/model and capacity of each heater | Mains or tank fed | Full clean possible | EXPANSION VESSEL INFO | |
|---|---|---|---|---|---|---|
| WH 02 | Female wc | Handywash | Mains | No | No | |

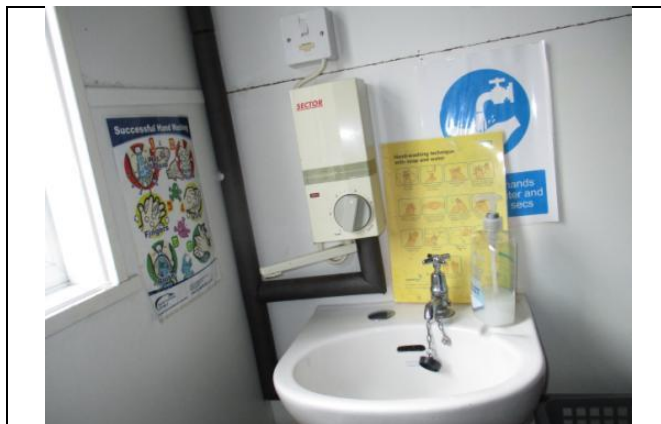
| Water Heater ID Number | Location | Make/model and capacity of each heater | Mains or tank fed | Full clean possible | EXPANSION VESSEL INFO | |
|---|---|---|---|---|---|---|
| WH 03 | Male wc | Handywash | Mains | No | No | |
