## LEGIONELLA RISK ASSESSMENT

### THE PREVENTION AND CONTROL OF LEGIONNAIRES' DISEASE

<b>Client:</b>	Wessex RF & CA
<b>Site:</b>	Blandford Platoon
<b>Address:</b>	15A Kingston Close, Blandford Forum DT11 7UQ
<b>Risk Rating:</b>	Low
<b>Report Ref:</b>	AQST/LRA/197
<b>Surveyed By:</b>	David Fletcher
<b>Survey Date:</b>	21 <sup>st</sup> September 2023
<b>Report Date:</b>	26 <sup>th</sup> October 2023
<b>Recommended Review Date:</b>	September 2025

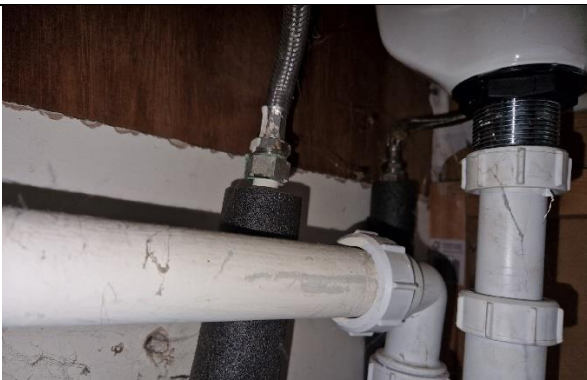
Example of flexi's

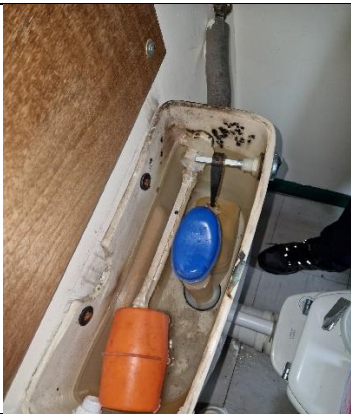
<p>Sign</p>	<p>Ladies wc broken flush handle</p>

<p>Ladies wc overflowing ball valve</p>

SYSTEM TYPES		RISK RATING
	<b>COLD WATER MAINS:</b>	
01	CWM stop tap should be clearly labelled	
	Actioned date:                      Company/initials:	
	<b>POINT OF USE WATER HEATERS:</b>	
03	WH 01 has the incorrect handle fitting – unable to auto vent – replace handle	Medium
	Actioned date:                      Company/initials:	
	<b>GENERAL: Control Schemes</b>	
01	Flexi hoses should be WRAS approved and not coiled/twisted	High
	Actioned date:                      Company/initials:	
02	The Ladies wc ball valve is faulty causing it to overflow and the flush is broken – requires replacing	Low
	Actioned date:                      Company/initials:
