## LEGIONELLA RISK ASSESSMENT

<b>Client:</b>	Wessex RF & CA
<b>Site:</b>	Newquay ACF
<b>Address:</b>	Crantock Street, Newquay, Cornwall TR7 1JJ
<b>Risk Rating:</b>	Medium
<b>Report Ref:</b>	AQST/LRA/169
<b>Surveyed By:</b>	Stephen Cross MWMSoc
<b>Survey Date:</b>	10 <sup>th</sup> August 2023
<b>Report Date:</b>	5 <sup>th</sup> October 2023
<b>Recommended Review Date:</b>	August 2025

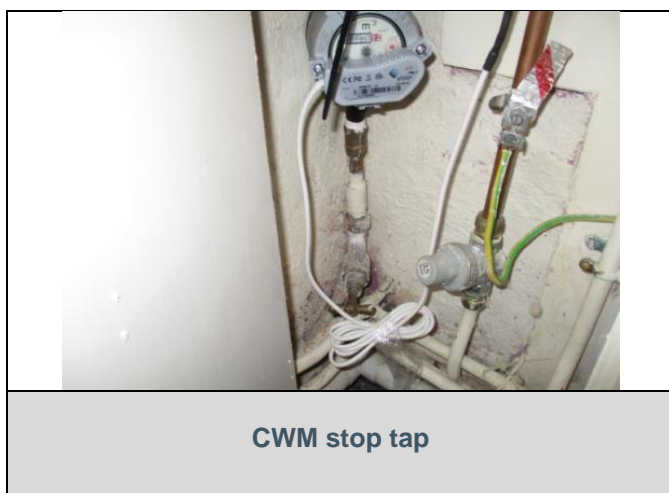
### Photos

Source of supply	Mains water
Number of mains cold water supply?	1
Location of main isolation valve?	Female wc
Is there a water meter installed?	Yes
Is the pipework labelled?	Yes
Materials of construction	Copper
Are there any materials or fittings visibly present on the mains water system, that do not conform to the Water Regulations Advisory Scheme (WRAS) directory?	No
Mains water temperature °C (sentinel outlets)	Nearest Tap to Incoming Main 18°C Furthest Tap from Incoming Main 18°C
Are all other distribution temperatures that were tested within the correct temperature range? i.e. Below 20 °C?	Yes
Are there any none flow through expansion vessels to any services on this system?	Yes
Is the pipework suitably insulated?	No
Does the cold-water supply have any inline filters including scale inhibitors/softeners?	None found
<b>Comments</b>	
Mains Water Supply Risk Score	<b>Medium</b>

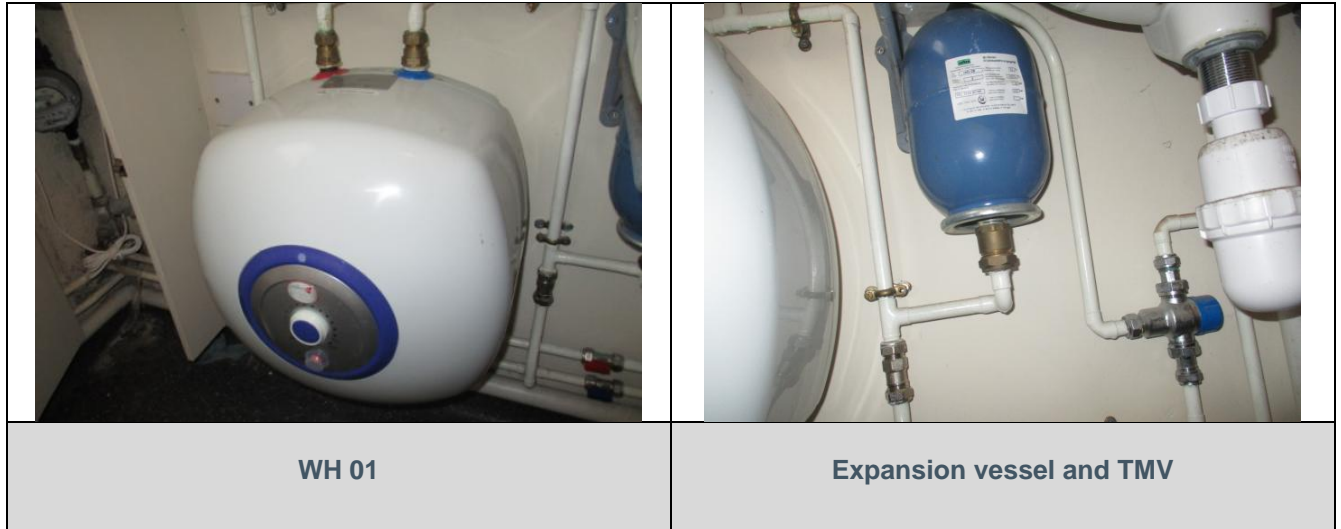
Water Heater ID Number	Location	Make/model and capacity of each heater	Mains or tank fed	Full clean possible	EXPANSION VESSEL INFO	
					Is there a pressure vessel – Yes/No	If yes – make model and size and whether fitted horizontally or vertically
WH 01	Female wc	Ariston 15ltr	Mains	No	Yes	2ltr vertical

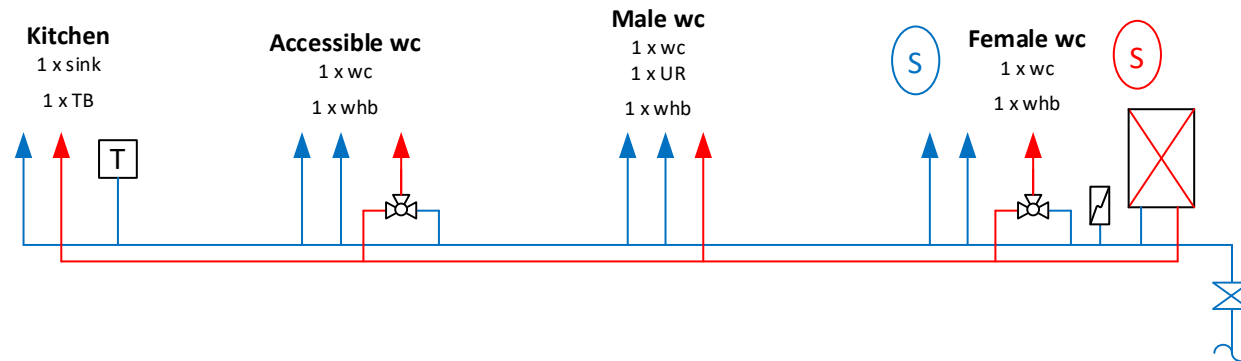
## 8. LINE DRAWINGS OF WATER SYSTEMS

NB: Due to the complexity of the pipe work at this site it is not possible to ensure the total accuracy of these line drawings. They may require revision.
