## LEGIONELLA RISK ASSESSMENT

| <b>Site:</b> | Wadebridge ACF |
| <b>Report Ref:</b> | AQST/LRA/178 |
| <b>Survey Date:</b> | 10 <sup>th</sup> August 2023 |

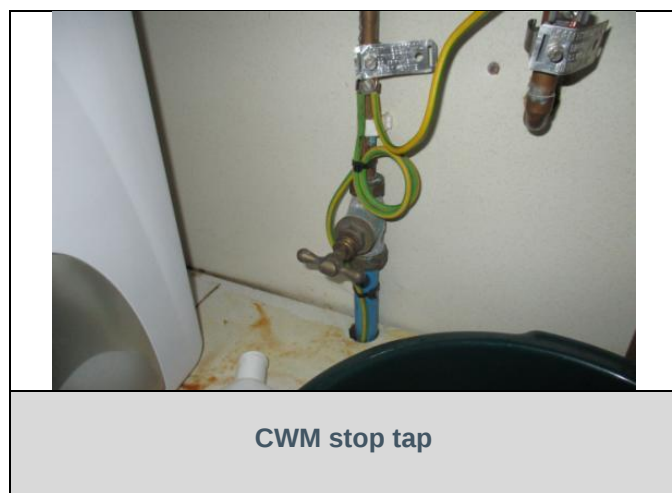
### Photos

| Location of main isolation valve? | Kitchen sink |
| Materials of construction | Copper |
| Mains water temperature °C (sentinel outlets) | Nearest Tap to Incoming Main 17°C<br>Furthest Tap from Incoming Main 17°C |
| Is the pipework suitably insulated? | No |
| Mains Water Supply Risk Score | Low |

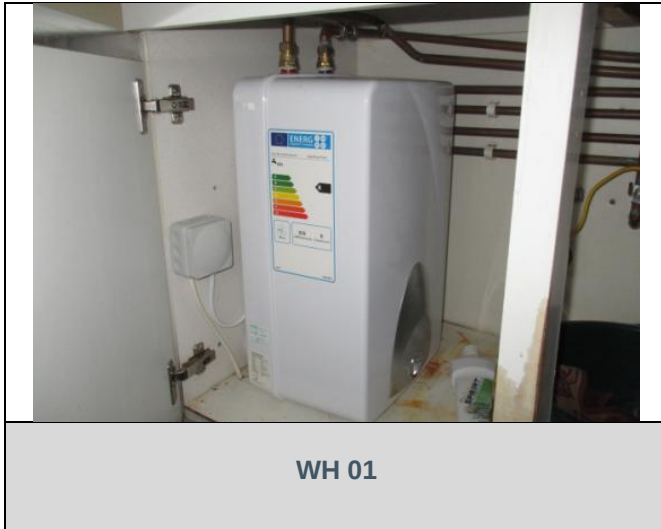
| Water Heater ID Number | Location | Make/model and capacity of each heater | Mains or tank fed | Full clean possible | EXPANSION VESSEL INFO | |
|---|---|---|---|---|---|---|
| WH 01 | Kitchen | Hyco 15ltr | Mains | No | No | |
