LEGIONELLA RISK ASSESSMENT

Client:	Wessex RF & CA
Site:	20 Bideford ATC
Address:	King George V Field, Park Lane, Bideford, Devon EX39 2QL
Risk Rating:	Low
Report Ref:	AQST/LRA/341
Surveyed By:	D. Fletcher
Survey Date:	27 th March 2024
Report Date:	19 th April 2024
Written By:	L. Blakemore
Checked By:	J. Rooney
Recommended Review Date:	March 2026

PREMISES : 20 Bideford ATC

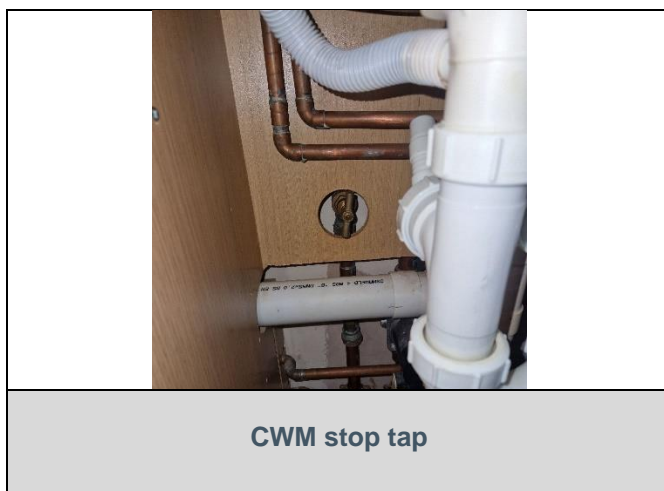
Photos

Source of supply	Towns mains
Number of mains cold water supply?	1
Location of main isolation valve?	Under kitchen sink
Is there a water meter installed?	Yes under combi
Is the pipework labelled?	No
Materials of construction	22mm copper
Are there any materials or fittings visibly present on the mains water system, that do not conform to the Water Regulations Advisory Scheme (WRAS) directory?	No
Mains water temperature °C (sentinel outlets)	Nearest Tap to Incoming Main 11.5 Furthest Tap from Incoming Main 11.5
Are all other distribution temperatures that were tested within the correct temperature range? i.e. Below 20 °C?	Yes
Are there any none flow through expansion vessels to any services on this system?	No
Is the pipework suitably insulated?	No
Does the cold-water supply have any inline filters including scale inhibitors/softeners?	No
COMMENTS	
Mains Water Supply Risk Score	Low

SYSTEM TYPES		RISK RATING
COLD WATER MAINS:		
01	CWM stop tap should be clearly labelled	Low
	Actioned date: Company/initials:	
POINT OF USE WATER HEATERS:		
01	Filling loop under combi should be disconnected	Low
	Actioned date: Company/initials:	
02	Combi boiler is faulty it gets to about 40°C then a fault code appears and the boiler cuts off, if it is reset it does it again – requires attention	High
	Actioned date: Company/initials:	
TMVs AND TMTs:		
01	TMV's require local isolation valves to enable servicing to be carried out (Gents has valves by whb3 which will shut all down together, Disabled has valves on strainers, Ladies doesn't have any)	High
	Actioned date: Company/initials:	
GENERAL: Control Schemes		
01	Monthly temperature checks should be carried out and recorded in the log book	High
	Actioned date: Company/initials:

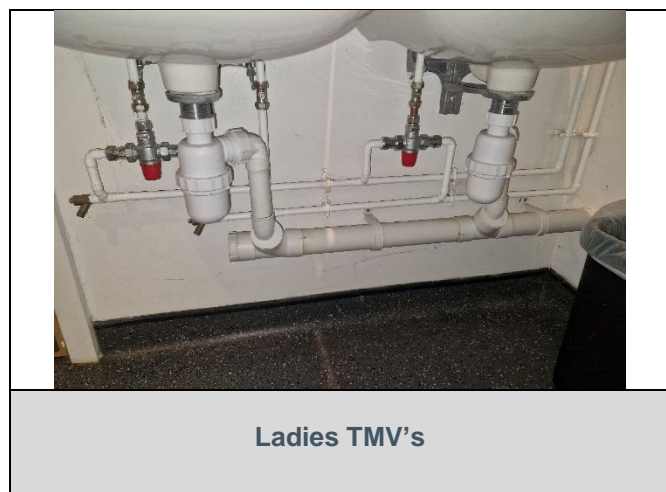
Are dead legs / infrequently used outlets present within system pipework?	No
Are thermostatic mixer valves present on individual outlets?	Yes
Are there single mixer valves serving a number of outlets?	No
Is the mixed temperature of the pipework >1m?	No
Are flexible hoses fitted to any services on the mains water system?	No
Is there any unused equipment connected?	No
Is any scale/debris present on any of the tap outlets?	No
Do any tap outlets have any spray or other inserts fitted?	No
Are strainers fitted?	Yes on TMV's
