LEGIONELLA RISK ASSESSMENT

Client:	Wessex RF & CA
Site:	1876 Kingsbridge ATC
Address:	Wallingford Road, Kingsbridge, Devon TQ7 1NF
Risk Rating:	Low
Report Ref:	AQST/LRA/523
Surveyed By:	R. Hill
Survey Date:	9 th May 2024
Report Date:	15 th May 2024
Written By:	L. Blakemore
Checked By:	J. Rooney
Recommended Review Date:	May 2026

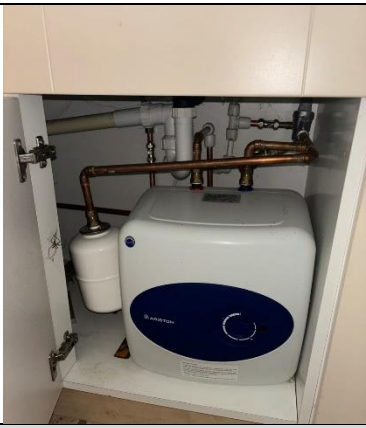
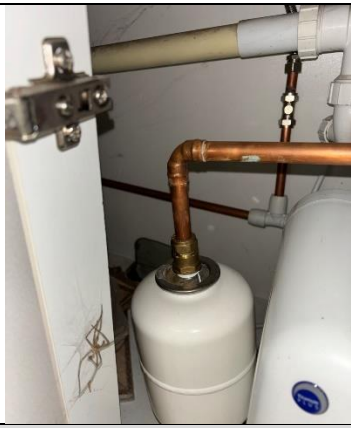
WH 01	Upside down expansion vessel
