## LEGIONELLA RISK ASSESSMENT

| <b>Site:</b> | Pilning ACF |
| <b>Report Ref:</b> | AQRA/AQ1177 |
| <b>Survey Date:</b> | 28 <sup>th</sup> June 2022 |

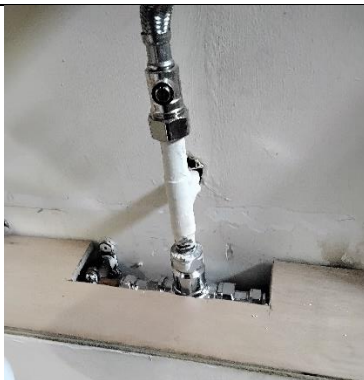
TMV in Ladies

| Are thermostatic mixer valves present on individual outlets? | Yes |
| Are flexible hoses fitted to any services on the mains water system? | Yes |

| SYSTEM TYPES | | RISK RATING |
|---|---|---|
| 01 | There is no evidence in the log book of TMV's being serviced. TMV's should be serviced annually | High |

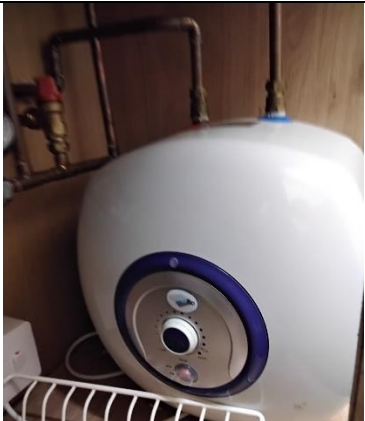
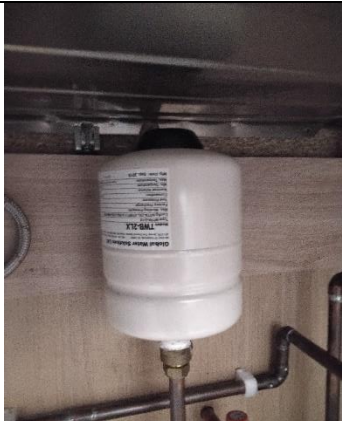
| Water heater 01 | Expansion vessel |

| Water Heater ID Number | Location | Make/model and capacity of each heater | Mains or tank fed | Full clean possible | EXPANSION VESSEL INFO | |
|---|---|---|---|---|---|---|
| WH 01 | Kitchen | Eva flow 15ltr | Mains | No | Yes | Globel 1ltr vertical |
