## LEGIONELLA RISK ASSESSMENT

| <b>Site:</b> | St Blazey Platoon |
| <b>Report Ref:</b> | AQST/LRA/175 |
| <b>Survey Date:</b> | 8 <sup>th</sup> August 2023 |

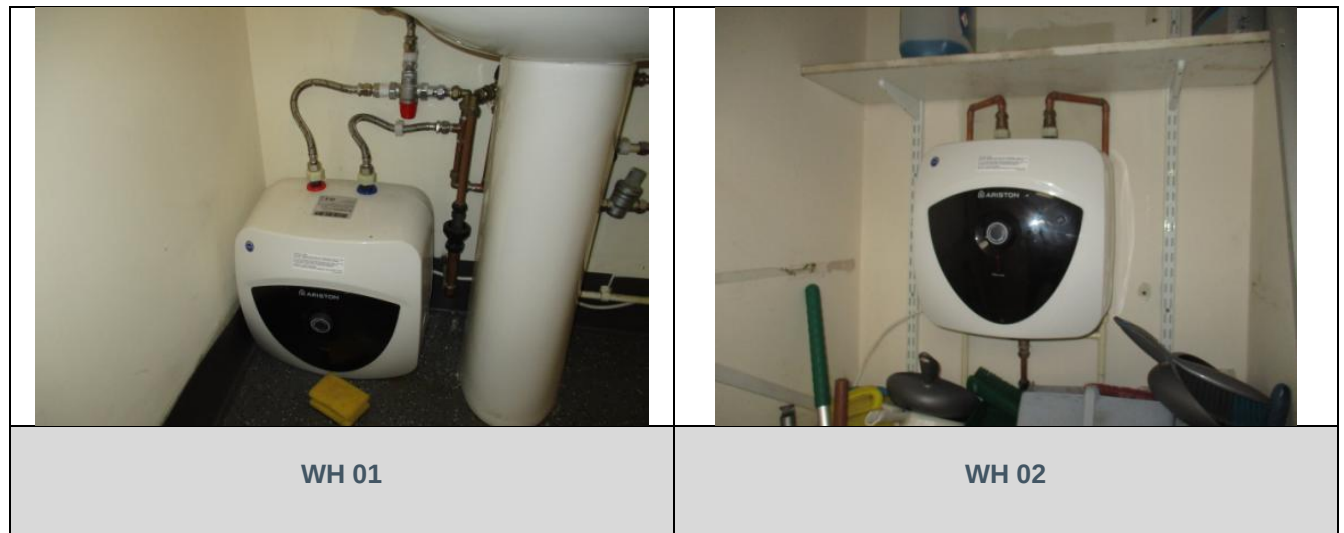
| Water Heater ID Number | Location | Make/model and capacity of each heater | Mains or tank fed | Full clean possible | EXPANSION VESSEL INFO | |
|---|---|---|---|---|---|---|
| WH 01 | Female wc | Ariston 10ltr | Mains | No | Yes | 2ltr vertical |
| WH 02 | Cleaners | Ariston 10oltr | Mains | No | Yes | 2ltr vertical |
