# LEGIONELLA RISK ASSESSMENT

| <b>Client:</b> | Wessex RF & CA |
| <b>Site:</b> | Tiverton Platoon |
| <b>Report Ref:</b> | AQST/LRA/492 |

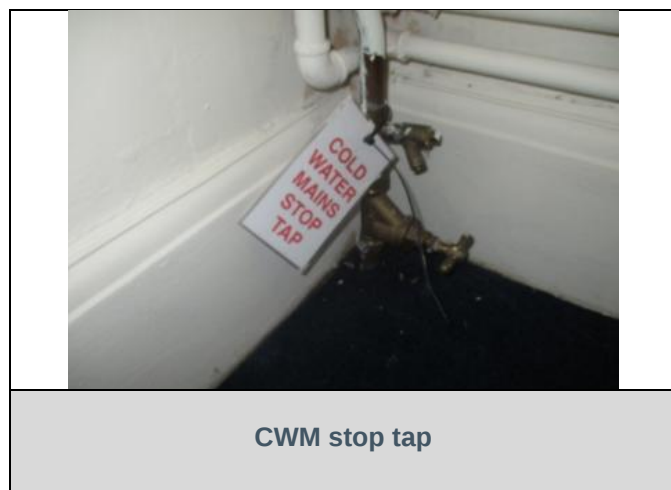
The incoming mains stop tap is in the front G/F office

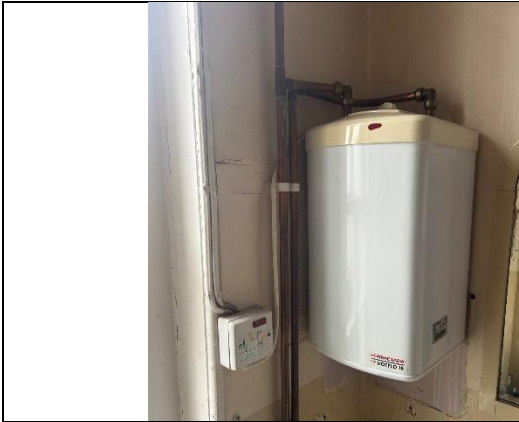
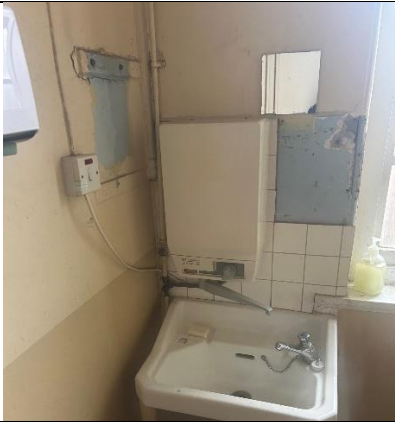
| <b>WH 01</b> | <b>WH 02</b> |

| SYSTEM TYPES | | RISK RATING |
|---|---|---|
| 01 | Outside toilet water heater is producing low temperatures. Water heater should be set to produce at least 50°C at outlets | High |
